DEFENDANT BEXAR COUNTY AND DEPUTY MOLINA'S  
MOTION TO STRIKE PLAINTIFF'S EXPERT

**RICARDO J. PALACIOS SR. EXPERT REPORT**

## Palacios Accident Reconstruction, LLC

**Date:** September 23, 2024

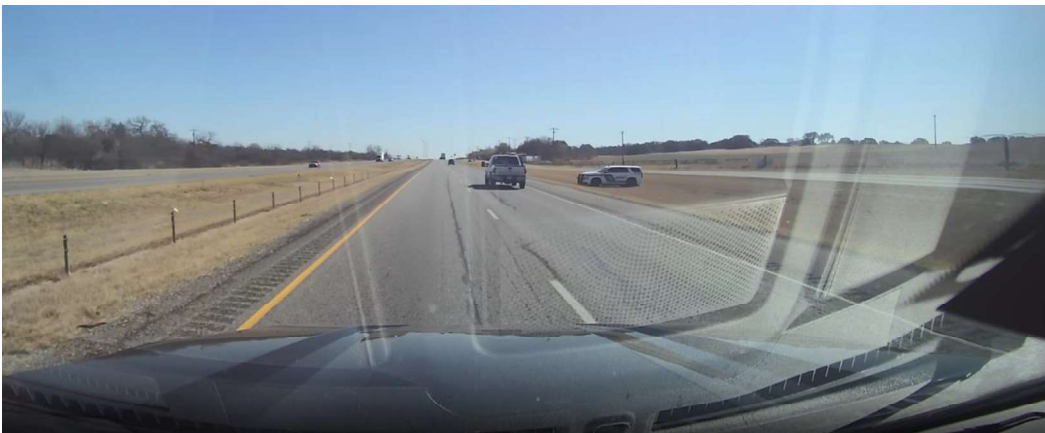
43. The structure of the barrow ditch and the place where Deputy Babb parked his patrol vehicle mean that the wheels of Deputy Babb's patrol vehicle were below the plane of the I-35 Northbound roadway and that Deputy Babb's patrol vehicle would have been angled slightly up.
44. Mr. Schott's dashboard camera footage confirms my conclusions that Deputy Babb's patrol car was lower than the I-35 Northbound roadway with the front tires slightly higher than the back tires.
